## PRODUCT SERVICE BULLETIN 2015-01

**PSB #:** 2015-01

**SUBJECT:** EXCESSIVE URETHANE COATING ON SPECTRA RESERVE RIPCORD

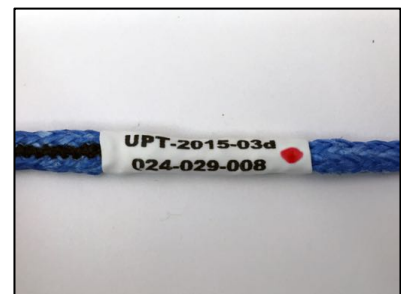
As a reminder use a Sharpie or similar permanent marker, and put a visible dot on the ripcord data sleeve. This will represent the initial treatment performed in June.

When you re-lubricate in July, put a second dot on the backside of the data sleeve, a third in August, and so on, until the replacement can be installed. This will allow any jumper to keep track of the monthly lubrication while the interim solution is in effect.
